**FUEL LUBRICITY IMPACT ON SHIPBOARD ENGINE AND FUEL
SYSTEMS AND SENSITIVITY OF U.S. NAVY DIESEL ENGINES
TO LOW-SULFUR DIESEL FUEL**

**INTERIM REPORT
TFLRF No. 414**

**U.S. Army TARDEC Fuels and Lubricants Research Facility
Southwest Research Institute® (SwRI®)
San Antonio, TX**

June 2011

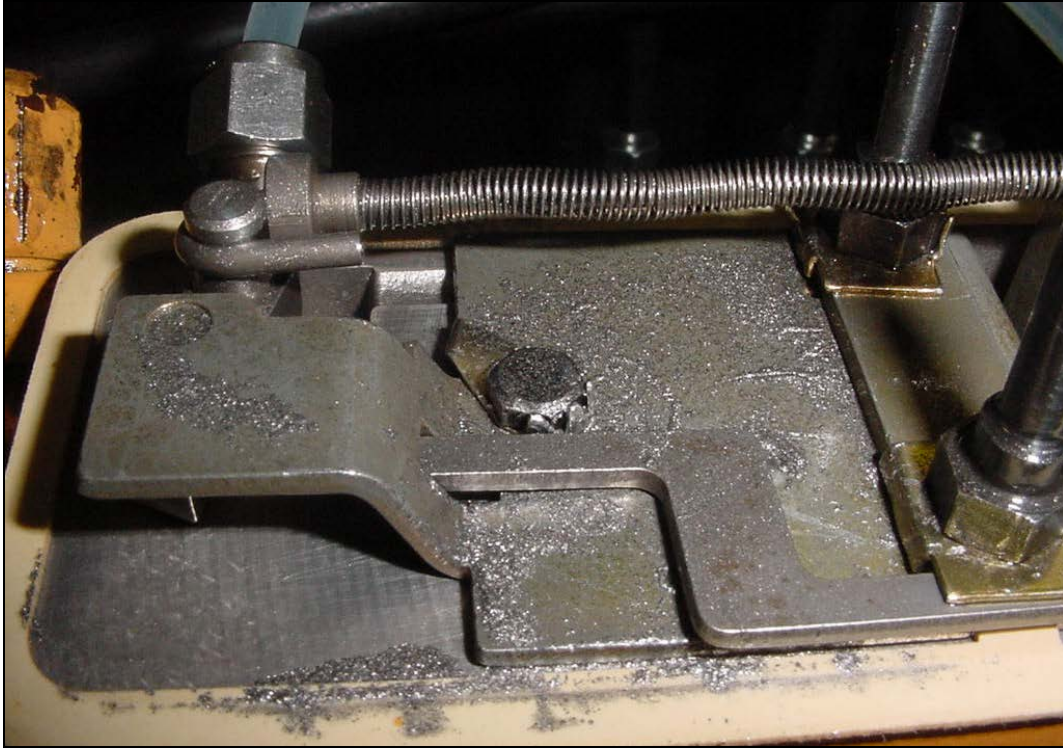
Figure 2. Delphi Pump Wear Debris with S-8 (F1000) Fuel

A used Delphi pump was operated on the test stand. The pump was inspected and built with serviceable components, then sent to a diesel fuel injection service facility to verify pump operation. The pump was installed on the test stand to validate the test stand drive coupling arrangement and alignment. The drive system was validated by operating the pump for several hours on diesel fuel and monitoring the pump performance. Since the pump was mounted on the stand it was decided to switch load the fuel from the diesel fuel to the Neat S-8 (F1000) fuel. The pump is used on the Cummins 3.9L “B” series engine that has the following military applications: USMC rough terrain crane, USN 4000 lb rough terrain forklift, and Army 7.5T wheeled crane. The pump stand was operated at rated speed on neat S-8 fuel, at 16.5 hours the pump had worn to the point where there was no fuel delivery. Inspection of the pump revealed extreme roller and cam wear. Figure 2 shows the wear debris in the pump. There were indications of severe fuel lubricity problems with using neat S-8 fuel in a fuel lubricated rotary injection pump.

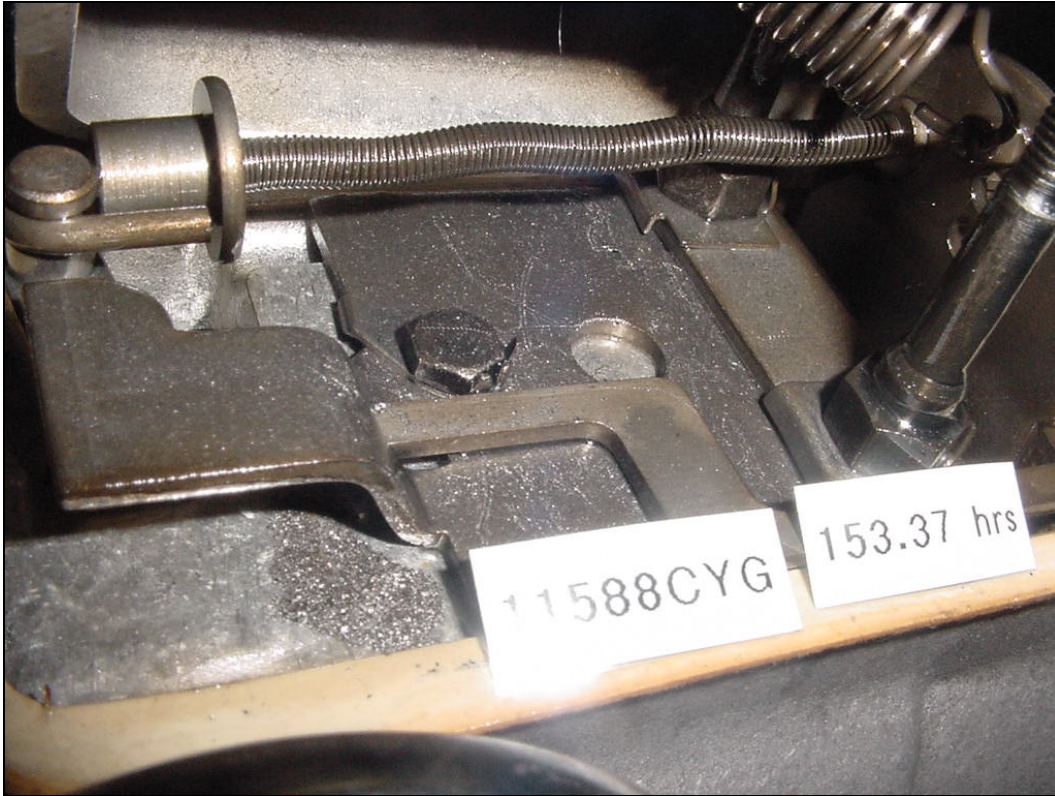
Figure 4. Metal Debris inside Pump at 153-hours for Test No. 4

A test of the 50/50 S-8/Jet A fuel with 9 ppm DCI-4A was evaluated for a Delphi rotary pump. The pump was run-in for 2 hours at the fuel injection service, however there was damage due to un-lubricated contact between the drive thrust washer and the aluminum housing. The service supplied a new housing and installed the internal components into the new housing, made adjustments, and performed a calibration check noted as New housing in Table 5. At 153 hours, the test was stopped because of apparent pump wear. As shown in Figure 3, fuel temperature was increasing (the middle plot), and pump flow was decreasing (bottom plot). The pump cover was removed and metal wear debris was present, Figure 4. The pump-metering valve felt as if there was debris in the bore.

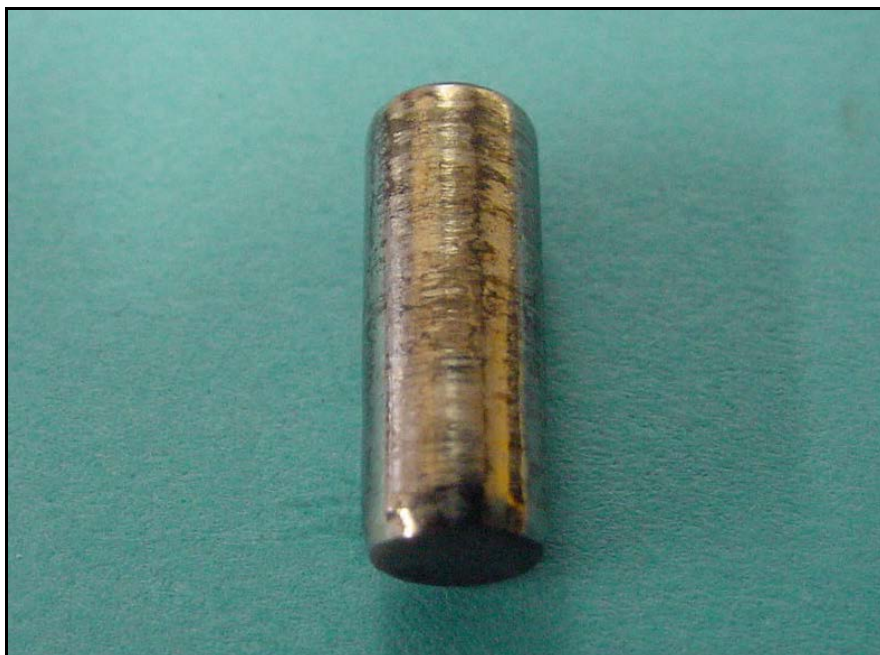
Figure 7. Delphi DPA Pump Cam Roller Wear with 50/50 S-8/Jet A Fuel with 22.5-ppm DCI-4A CI/LI Additive

The cam roller from the DPA pump is shown in Figure 7. The wear seen on the roller in Figure 7 is typical for all four rollers. Not evident from the photograph, the roller is slightly tapered due to wear. Once the roller becomes tapered, wear in the pump would have accelerated because the roller would no longer roll on an axis parallel to the driveshaft axis of rotation. Figure 8 shows one of the roller shoes, with severe wear that suggest the roller was shifting in the shoe, and not just rotating. The level of wear debris evident throughout the pump is shown on the governor weight in Figure 9.

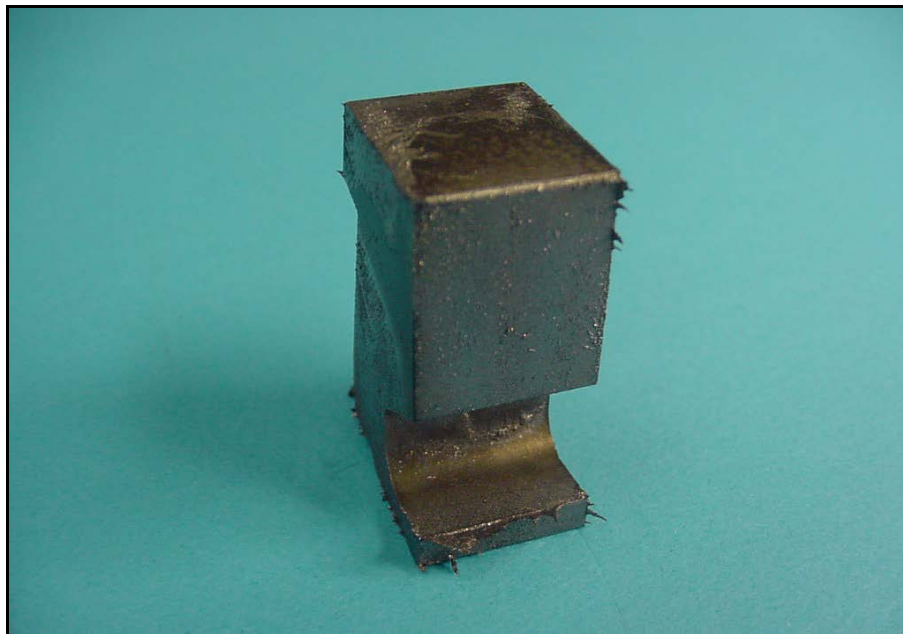
Figure 9. Delphi DPA Pump Governor Weight with 50/50 S-8/Jet A Fuel with 22.5-ppm DCI-4A CI/LI Additive

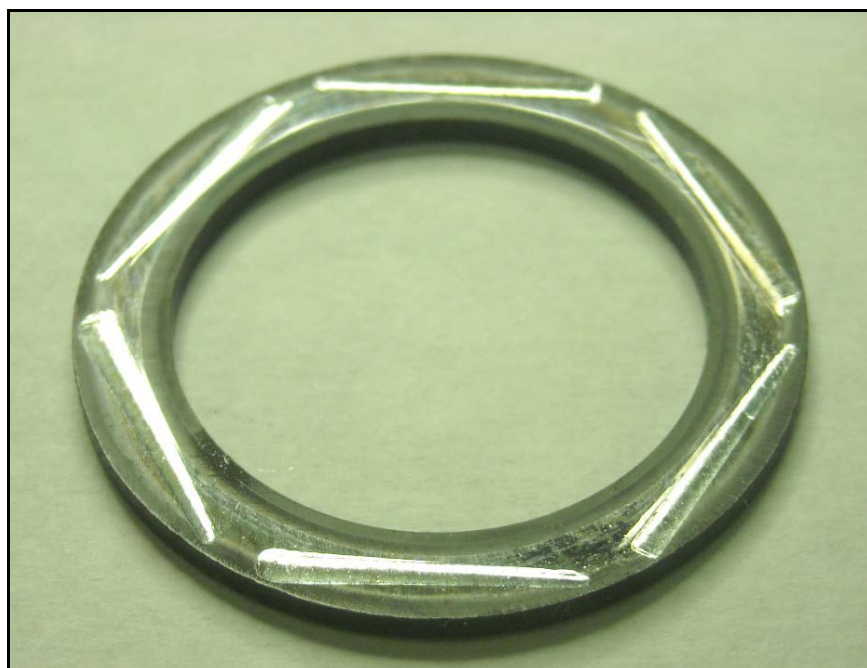
Figure 12. Wear Scars on Governor Thrust Washer from Governor Weights at 250 hours with S-8/Jet A + 22.5 ppm DCI-4A Fuel

Figure 11 is the metering valve from the test pump revealing an unusual wear pattern. The governor thrust washer from the S-8/Jet A + 22.5 ppm DCI-4A test revealed the highly unusual wear pattern shown in Figure 12. The thrust washer appeared to stop rotating and distinct wear scars formed from the action of the governor weights. Figure 13 shows a thrust washer with a more typical wear pattern. Other components of the governor linkage also revealed larger than normal wear scars.

CAM RING	Looks about the same as it did before test. Had some wear marks before test but was not replaced.		
THRUST. WASH.	Unusual wear pattern from the foot of the weights. There is four weights and there was six grooves worn into the washer. Normally the wear scar is consistent around the surface of the washer.		
THRUST. SLEEVE.	Worn from fingers of governor arm.		
GOV. WEIGHTS	Heavy wear on foot from washer contact. Wear on heel from weight cage contact.		
LINK HOOK	Groove worn into linkage long spring retainer.		
M-VALVE	Unusual chatter wear marks on valve.		
DR. SHAFT SPLINE	Normal Wear.		
DR. SHAFT SEAL AREA	Worn from seal contact. Some wear at bearing pilot contact.		
ADV. PISTON	Normal Wear. One scratch.		
HOUSING	Normal Wear.		
R/R DIMENSION - A/E	1.9930" Before test. As rec. from factory. Diesel Injection adjusted on the stand starting point unknown. After test - 1.9870"		
R/R DIMENSION - D/H	1.9930" Before test. As rec. from factory. Diesel Injection adjusted on the stand starting point unknown. After test - 1.9864"

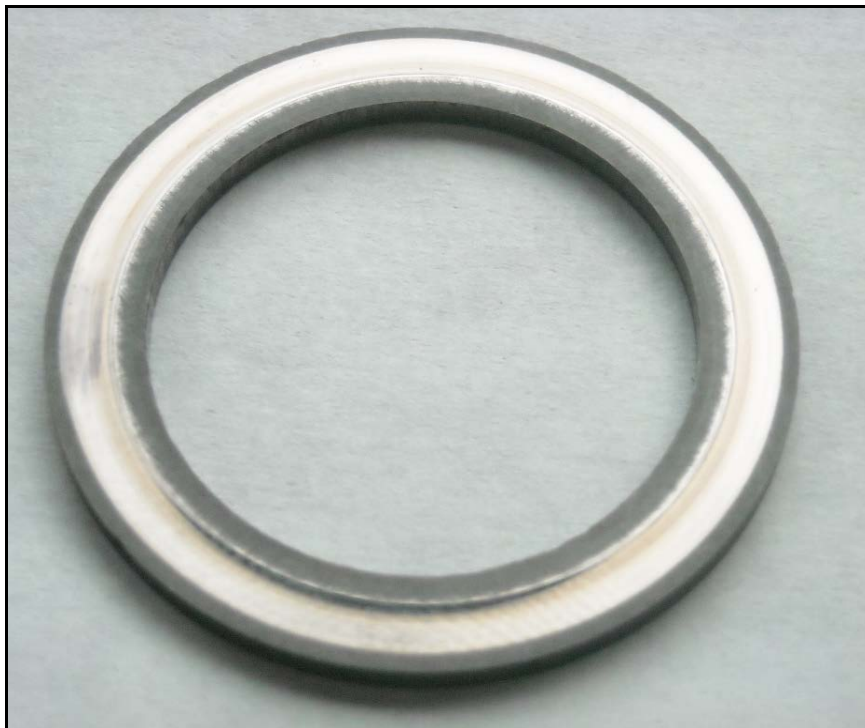
**Figure 13. Delphi Thrust Washer with Typical Wear Pattern
after 500 hours Jet A Fuel**

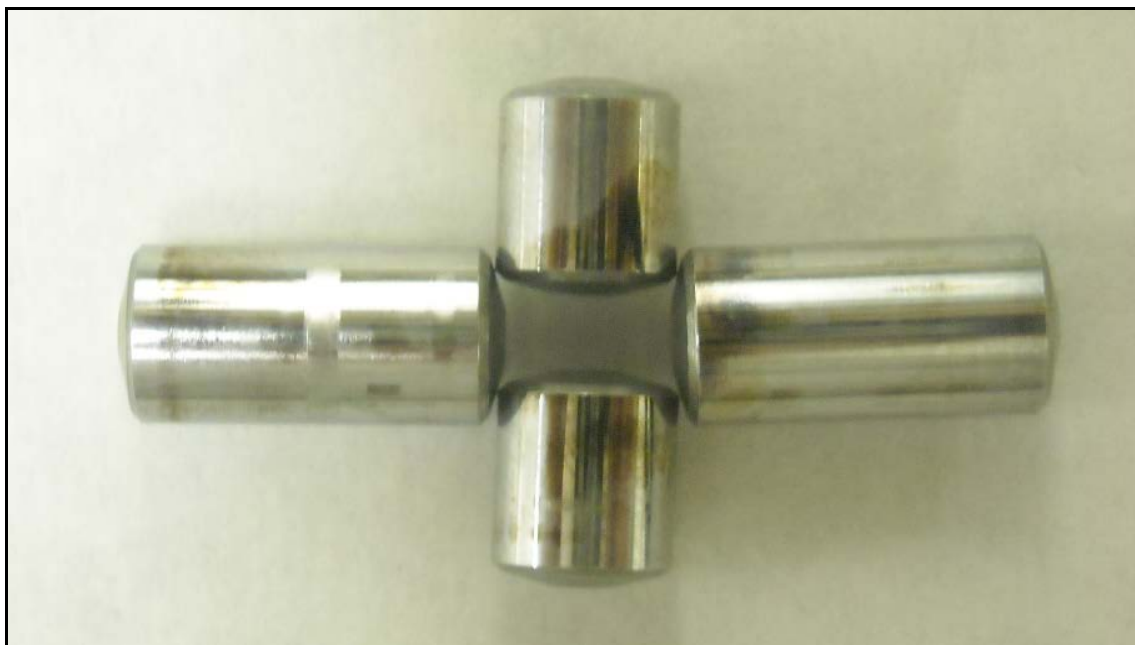
Figure 14. Delphi Pumping Plunger Wear Scars after Operation with S-8/Jet A + 22.5 ppm DCI-4A Fuel

The pumping plungers, Figure 14, from the S-8/Jet A + 22.5 ppm DCI-4A test revealed wear that caused them to cock in their bores when pressure was applied to measure the roller-to-roller dimension. The roller shoes in Figure 15 revealed substantial wear scars on the sides contacting the pumping plungers.
